NDI No. PA 00908
PENN DER No. 63-78

REFUSE SETTLING BASIN

UNITED STATES STEEL CORPORATION
RAW MATERIALS DIVISION

PHASE I INSPECTION REPORT
NATIONAL DAM INSPECTION PROGRAM

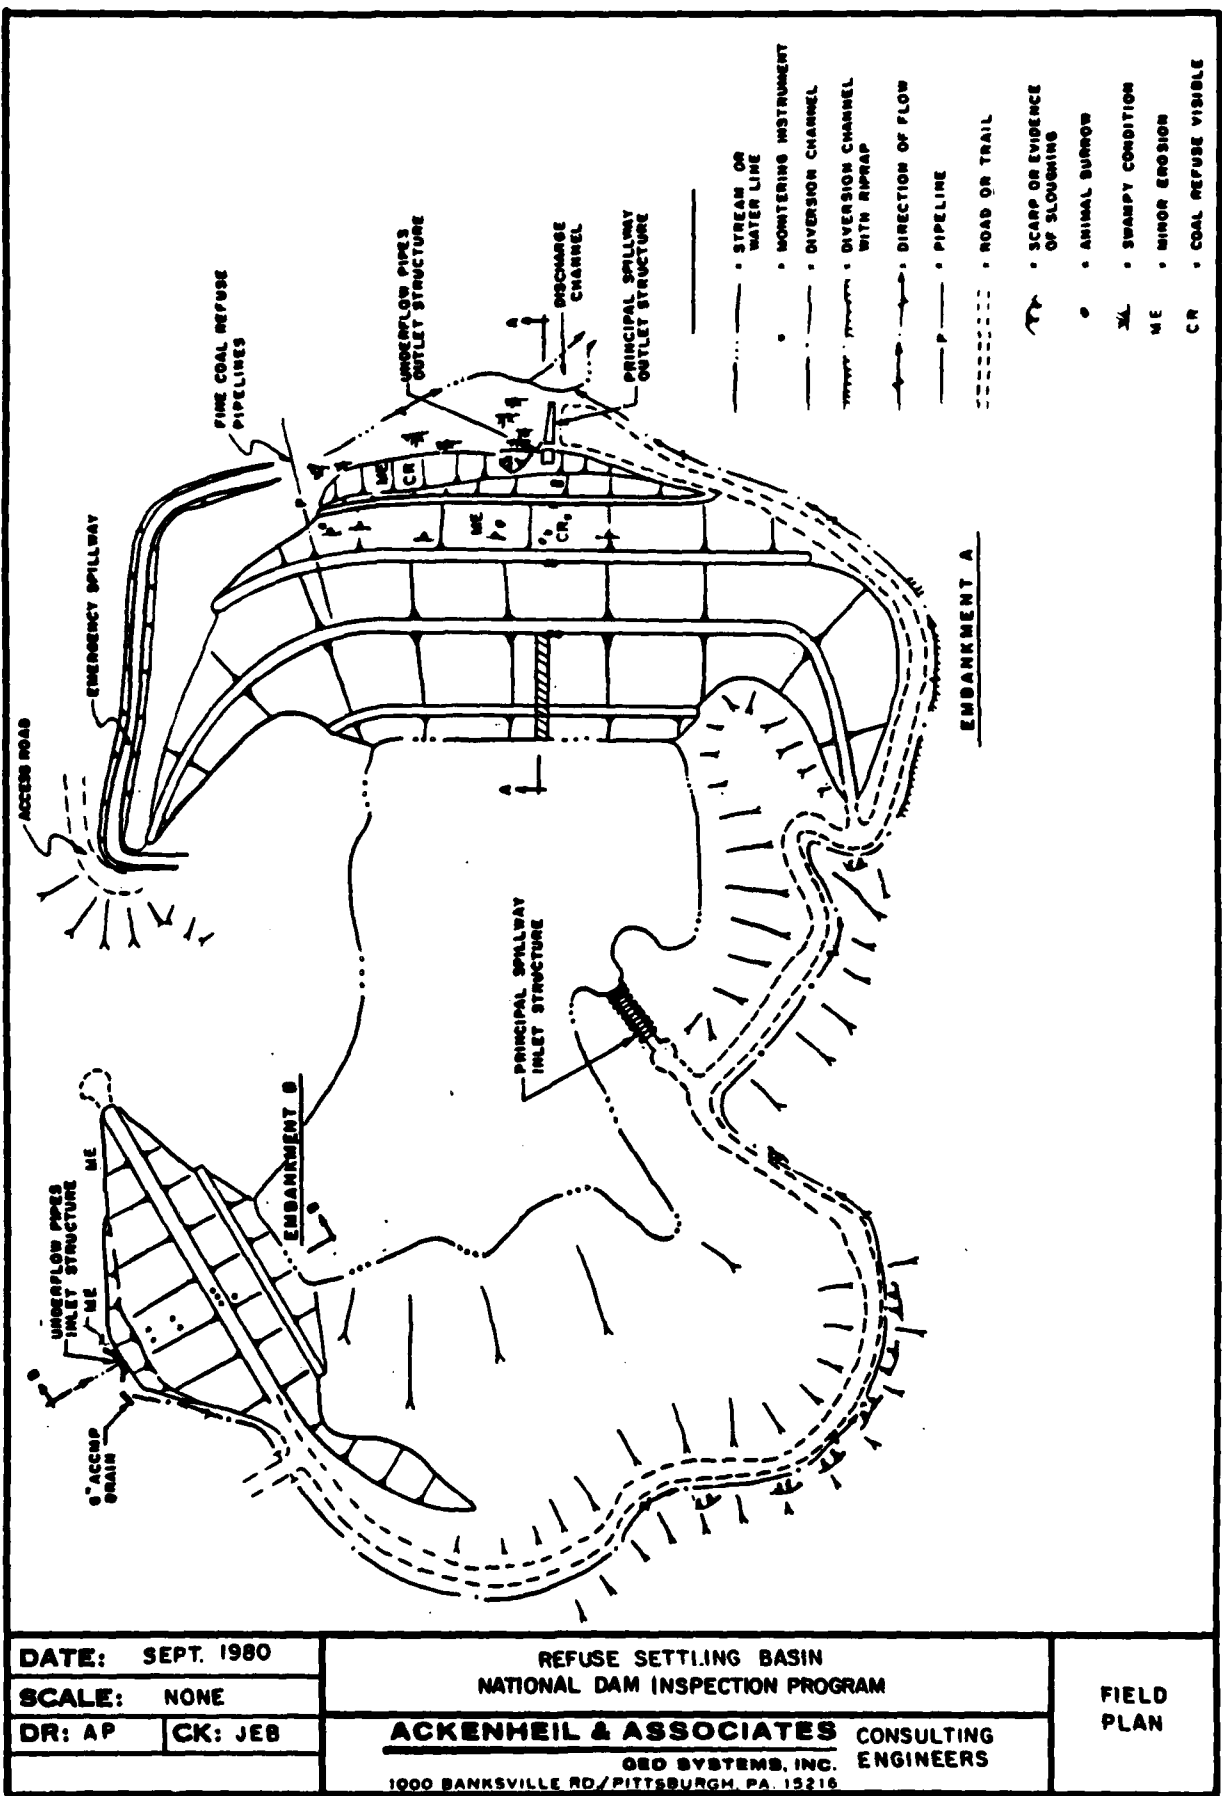
DATE: SEPT. 1980		REFUSE SETTLING BASIN NATIONAL DAM INSPECTION PROGRAM		FIELD PLAN
SCALE: NONE				
DR: AP	CK: JEB	ACKENHEIL & ASSOCIATES CONSULTING ENGINEERS		
		GEO SYSTEMS, INC. 1000 BANKSVILLE RD./PITTSBURGH, PA. 15216

<u>VISUAL EXAMINATION OF</u>	<u>OBSERVATIONS</u>	<u>REMARKS OR RECOMMENDATIONS</u>
<u>SLOPES</u>	The reservoir slopes were observed to be generally flat to moderate and were entirely grassed both above and below the embankment crest elevation. Minor surficial sloughing was observed at several locations on steeper slopes both below and above the embankment crest elevation.	
<u>INLET STREAM</u>	There is no natural inlet stream to reservoir and upper watershed flows are diverted away from the impoundment by a diversion channel. Fine coal refuse (slurry) is transported to the impoundment by two steel pipes that discharge onto the upstream slope of Embankment A near the center of the dam.	
<u>SEDIMENTATION</u>	The impoundment area is a disposal facility for fine coal refuse (slurry) from the Maple Creek Mine preparation plant. Consequently, considerable sediment has been impounded particularly in the area below the outfall for the slurry pipelines.
